FACILITY COMPLIANCE AUDIT REPORT

Division of Waste Management Solid Waste Section

Date of Audit: 07/01/09

Champion International Industrial Landfill
State Road 1613
Canton, NC 28716

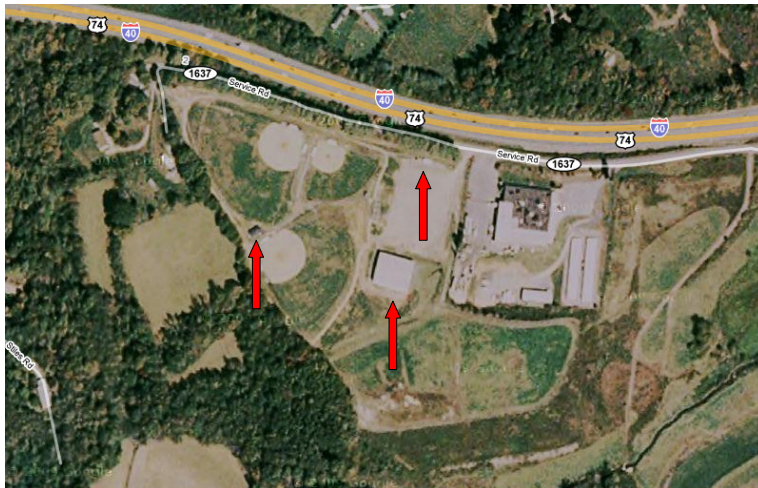
Activity #1: Town of Canton/Baseball Park

Arrows indicate enclosed structures: concession stand/announcing booth/restroom building, barn, and sheds. As stated previously, the Section requests that the permit holder supply documentation (within 30 days) establishing an approved variance from the post-closure requirement for monitoring. **Additionally, the Section requests documentation regarding approval for the construction and ongoing site activities associated with the baseball park.**

At this time, the Section requests that the permit holder supply documentation (within 30 days) establishing an approved variance from this post-closure requirement with respect to the structures located on the fill area referred to as Landfill No. 5-C (from submitted Closure Plan figures). See comment #8 for details on these structures.

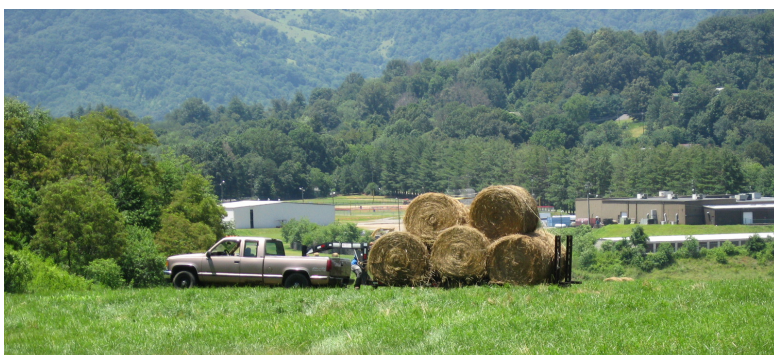
Activity #2: Hayfields

As observed during the audit, and noted in previous documentation (Examination of Landfill No. 1 report dated June 1, 1999, and submitted by Earth Tech Inc. on behalf of Champion International Corporation), the upper surface of the closed landfill has been used as a hayfield. This activity pre-dates the approved closure of the landfill.

The Section requests that the permit holder supply documentation (within 30 days) establishing this as an approved site activity. Additionally, please document for the Section the end-use for the hay generated from this location.
